SITE INSPECTION REPORT
FOR
MUNICIPAL LANDFILL
ARLINGTON HEIGHTS, ILLINOIS
F05-8708-001
ILD981193428
PAN: FIL0533SA

JANUARY 28, 1988

DATE: January 28, 1988
TO: File *MR*
FROM: Gerard Breen
SUBJECT: Illinois/F05-8708-001/FIL0533SA
Arlington Heights/Municipal Landfill
ILD981193428

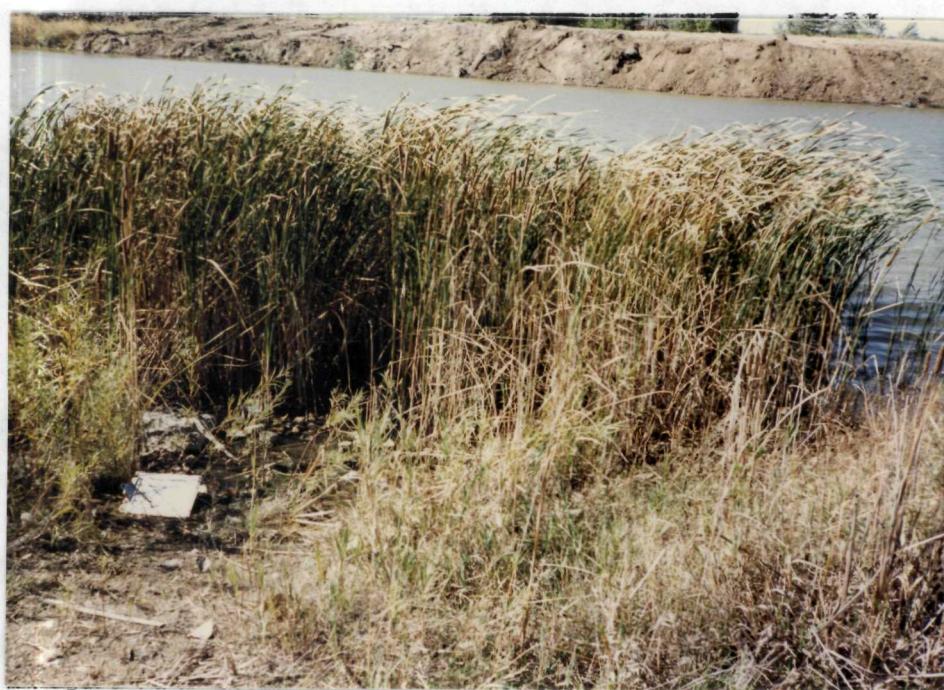
Soil 1 (S1)

DESCRIPTION: FAR VIEW OF THE LOCATION OF SOIL SAMPLE 1 AT THE SHORE
OF THE LAKE AMONG THE REEDS. (LAKE A)DATE 10-1-87TIME 11:57 A.M. P.M.DIRECTION: N NNE NE ENE
E ESE SE SSE
S SSW SW WSW
W WNW NW NNWWEATHER Sunny, windy,
and coolSITE Municipal Landfill-
Arlington HeightsTDD# F05-8708-001

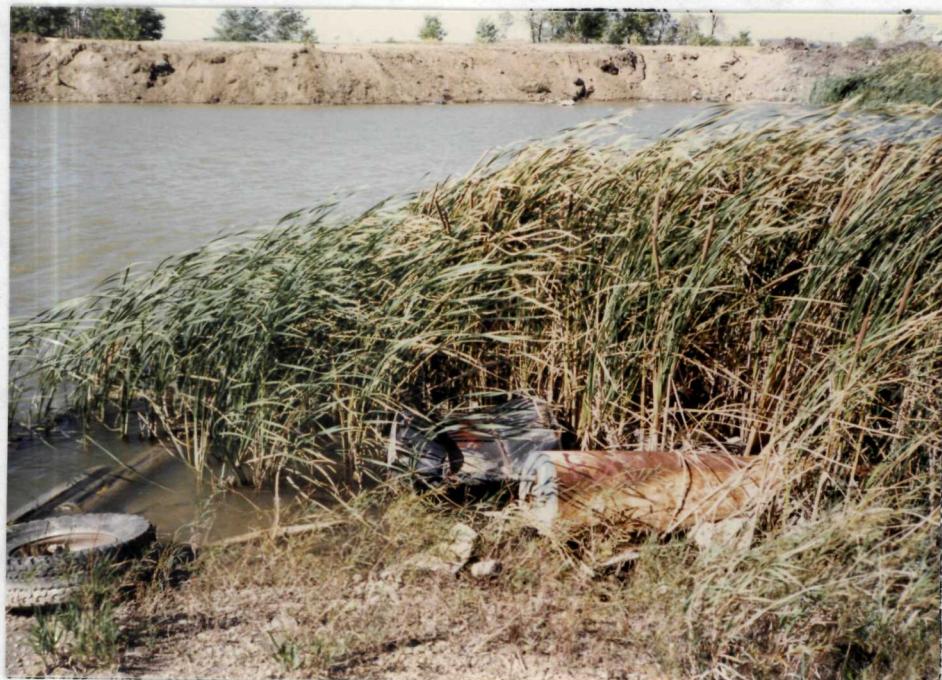
DESCRIPTION: CRUSHED BARREL AND TANK AT SOUTH END OF REEDS FROM
WHERE SOIL SAMPLE 1 WAS TAKEN. (LAKE A)

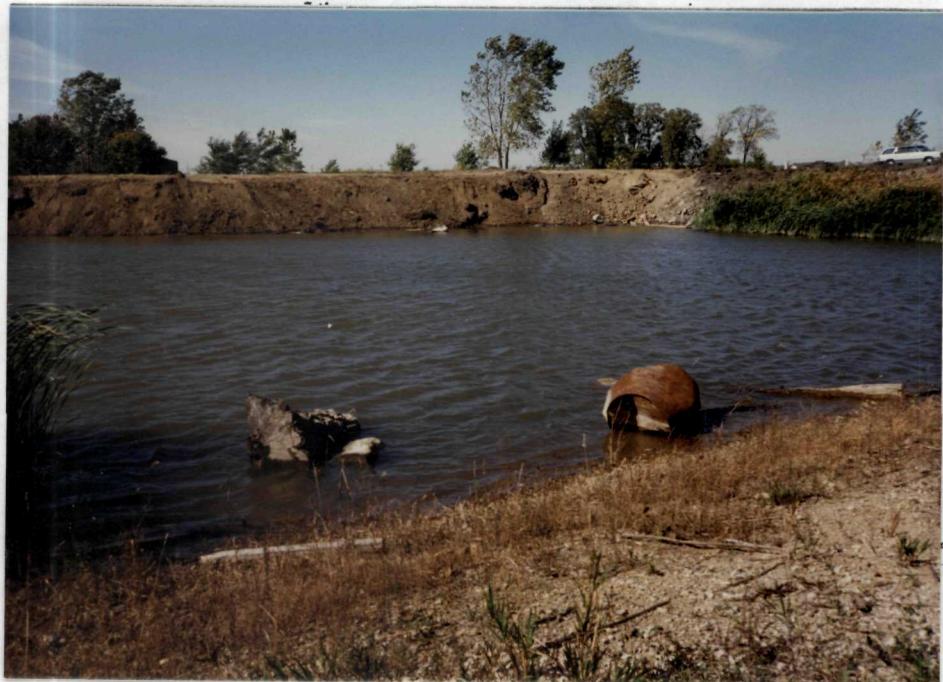
N/ADESCRIPTION: Lake at the base of the large hill. Looking to the NW -
a rusted drum in the lake. (LAKE A)

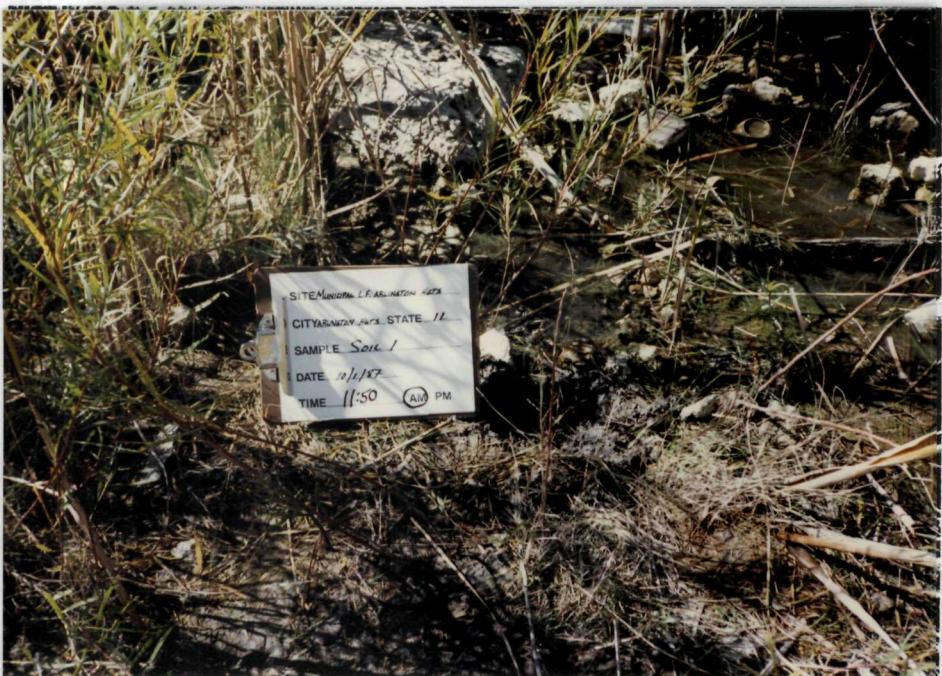
S1DESCRIPTION: Soil sample 1 in the REEDS at the shore of the Lake of photo
#1 (close-up)

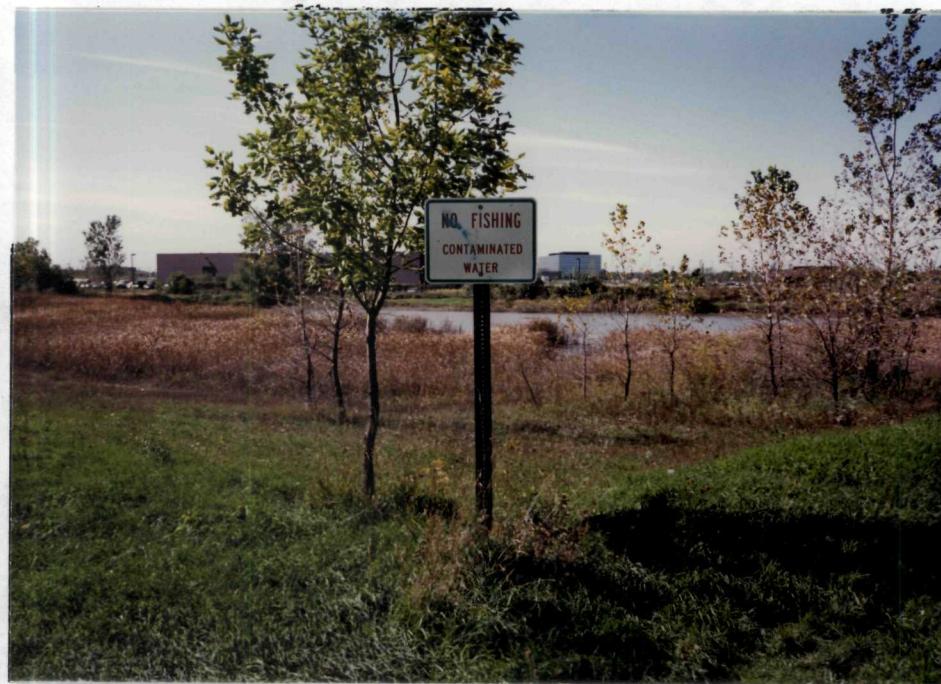
DESCRIPTION: 'CONTAMINATED WATER' SIGN AT THE NORTH EAST APPROACH TO
 LAKE B

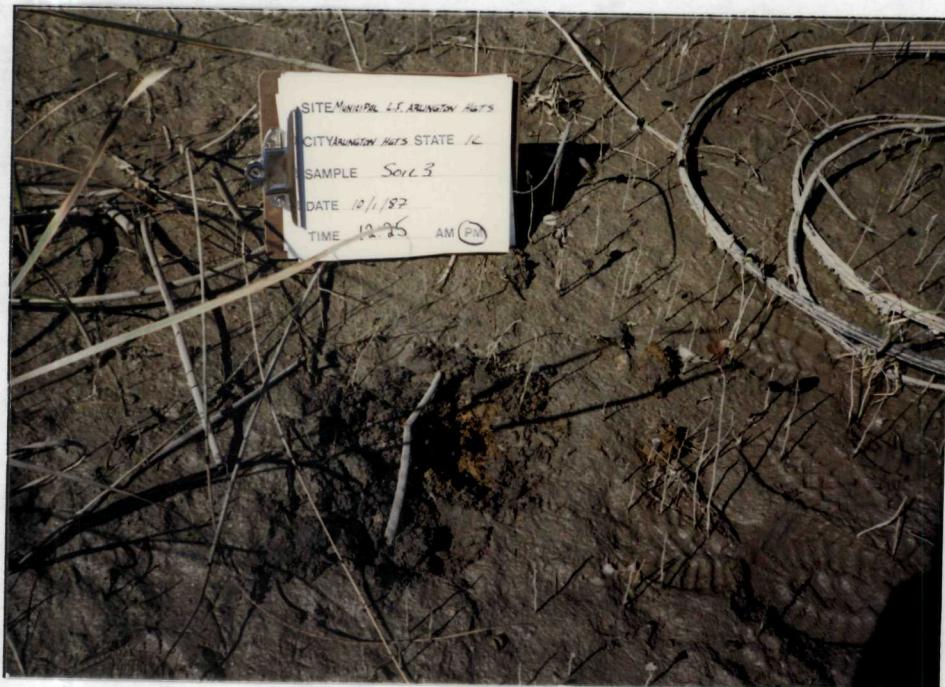
Soil 3 (S3) composite

DESCRIPTION: LOCATION OF SOIL SAMPLE 3 (S3) ON A MUD FLAT OF LAKE B;
 IN THE NORTHEAST CORNER OF THE LAKE.

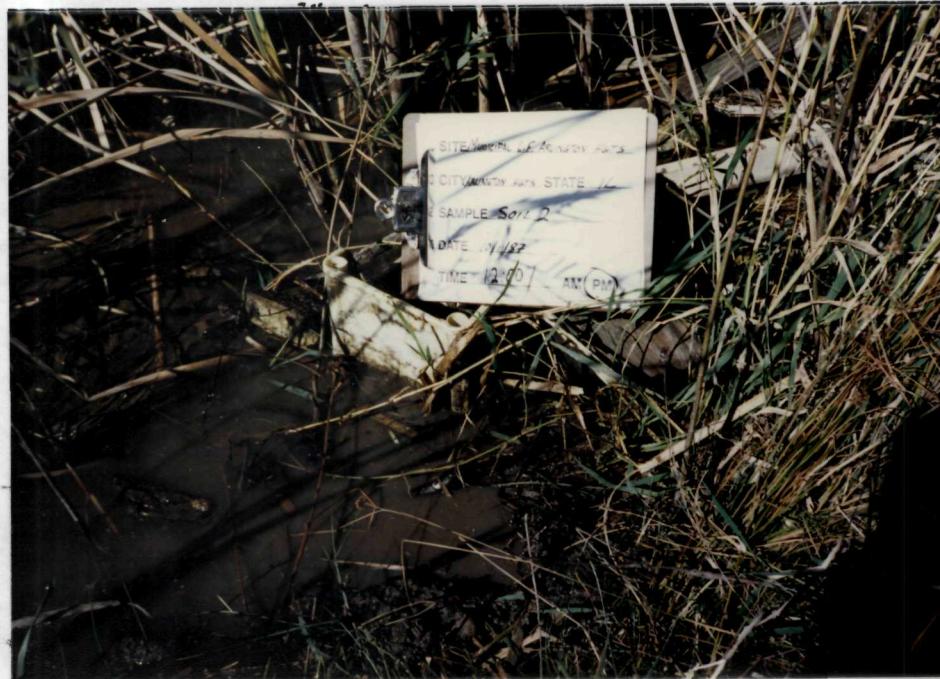
Soil 2 (S2)

DESCRIPTION: FAR VIEW OF SOIL SAMPLE 2 (S2) AMONG THE REEDS AT
THE SOUTH EAST corner of LAKE A.

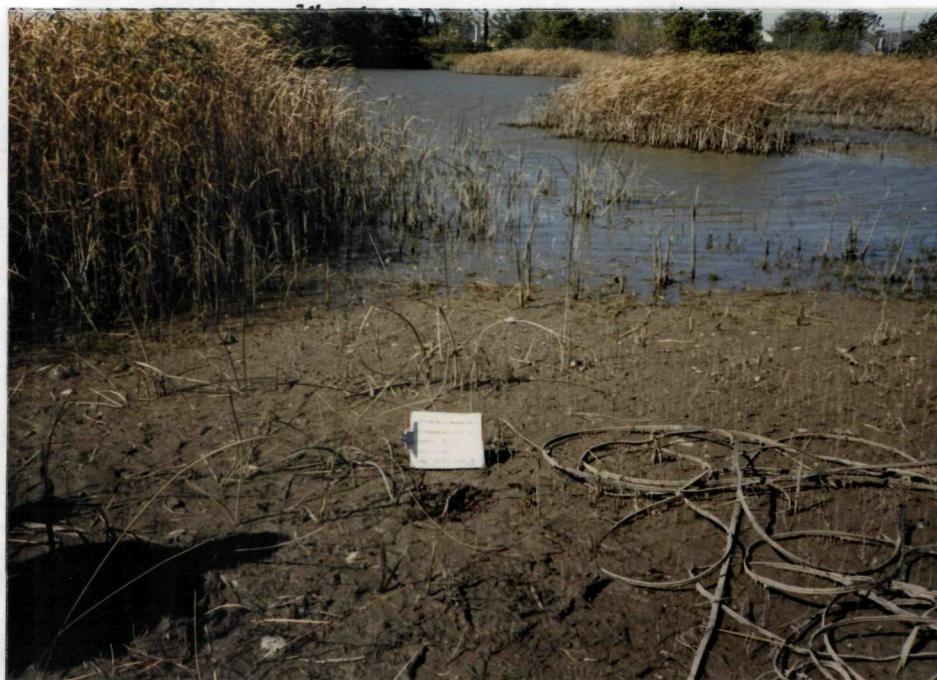
Soil 3 (S3)

DESCRIPTION: FAR VIEW OF SOIL SAMPLE 3 ON A MUD FLAT OF LAKE B. THIS SAMPLE IS A COMPOSITE SAMPLE.DATE 10-1-87TIME 12:26 A.M. P.M.

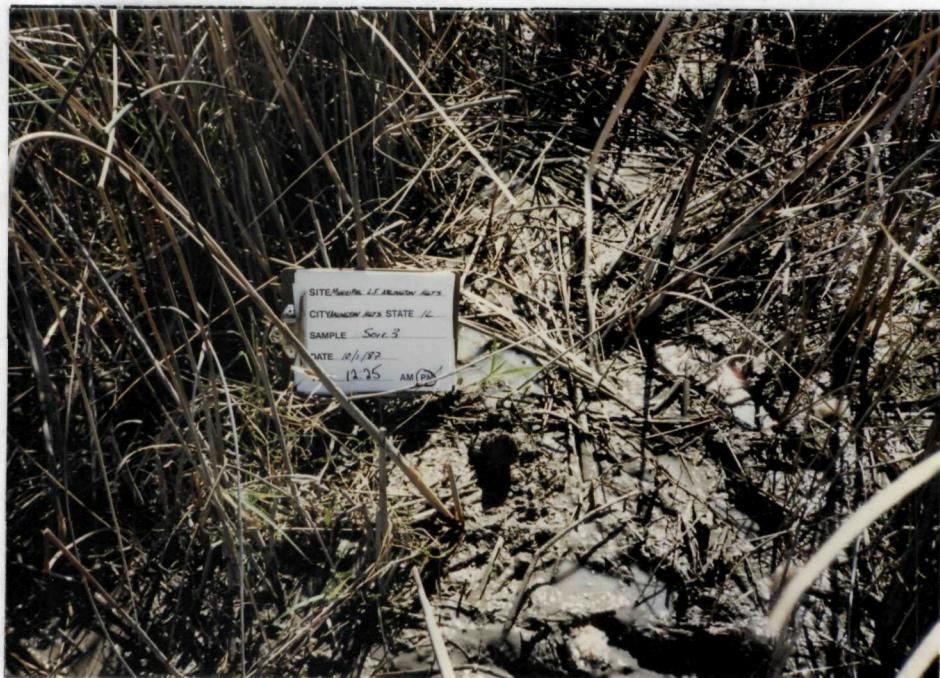
Soil 3 (COMPOSITE.)

DESCRIPTION: The soil sample was taken in the reeds immediately south of the mud flat from which the other sample of the composite was taken.

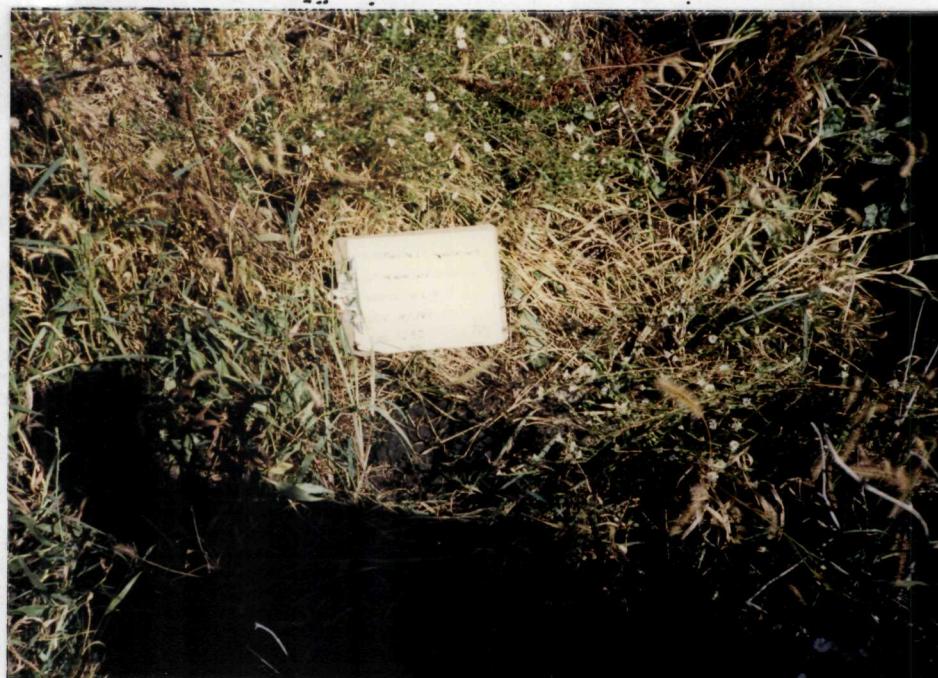
Soil 4 (S4)

DESCRIPTION: CLOSE-UP OF LOCATION OF SOIL SAMPLE 4 TAKEN IN THE RAVINE AT THE NORTH AND EAST CORNER OF THE LARGE FILL HILL.DATE 10-1-87TIME 12:50 A.M. P.M.

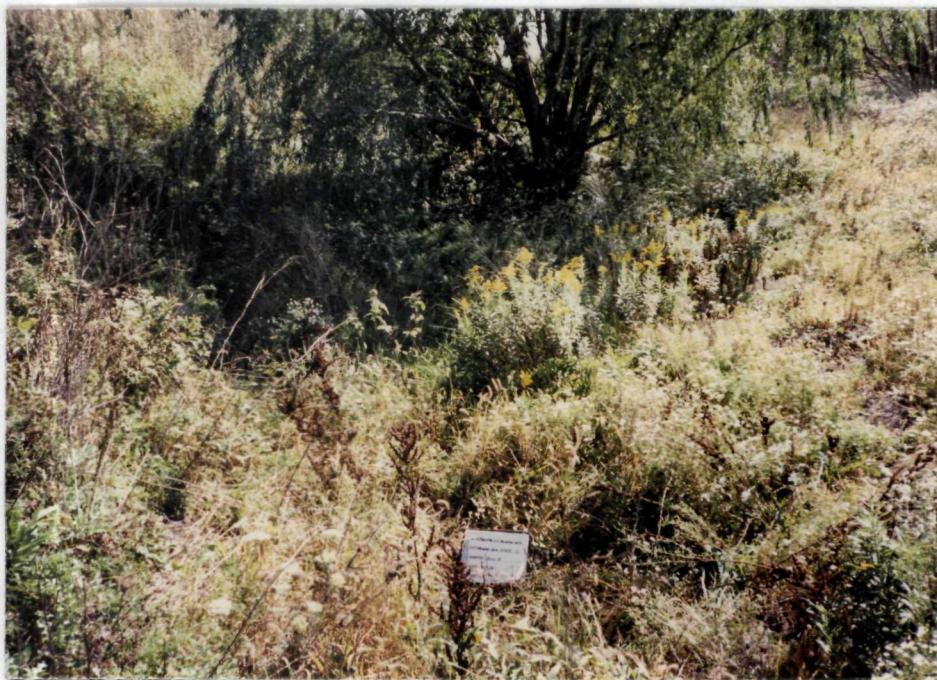
Soil 4 (S4)

DESCRIPTION: FAIR VIEW OF SOIL SAMPLE 4 IN THE RAVINE.

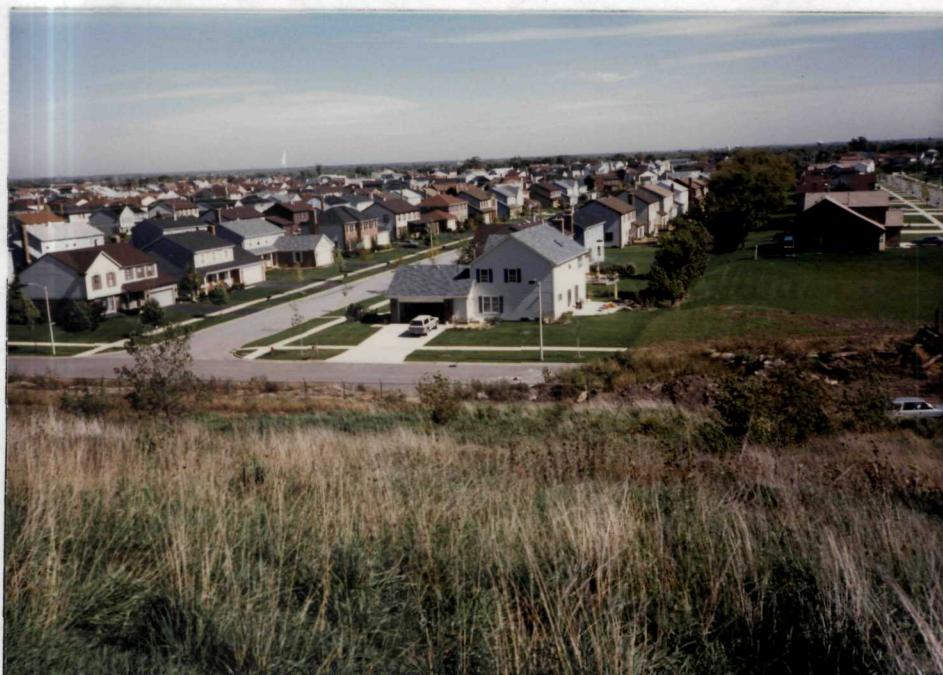
DESCRIPTION: RESIDENTIAL AREA TO THE NORTHEAST AND EAST OF LARGE HILL. NOTE FENCE
ENDING NEAR DEBRIS PILE, RIGHT OF CENTER.

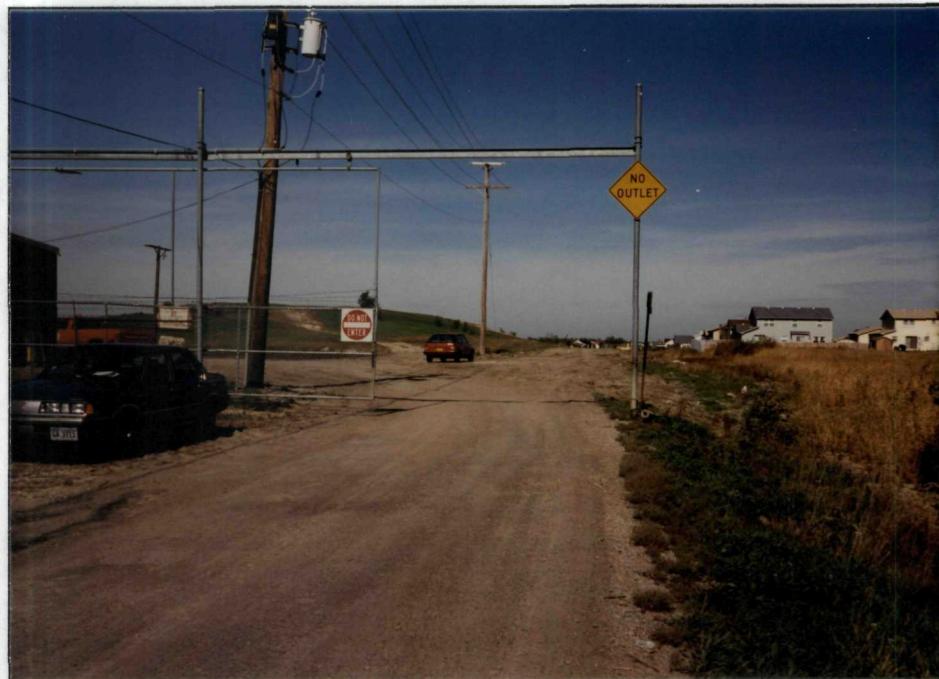
DESCRIPTION: ENTRANCE GATE AT SOUTHEAST CORNER OF SITE. NOTE LACK OF FENCE ON THE EAST SIDE AND ROAD UP THE LARGE FILL HILL.

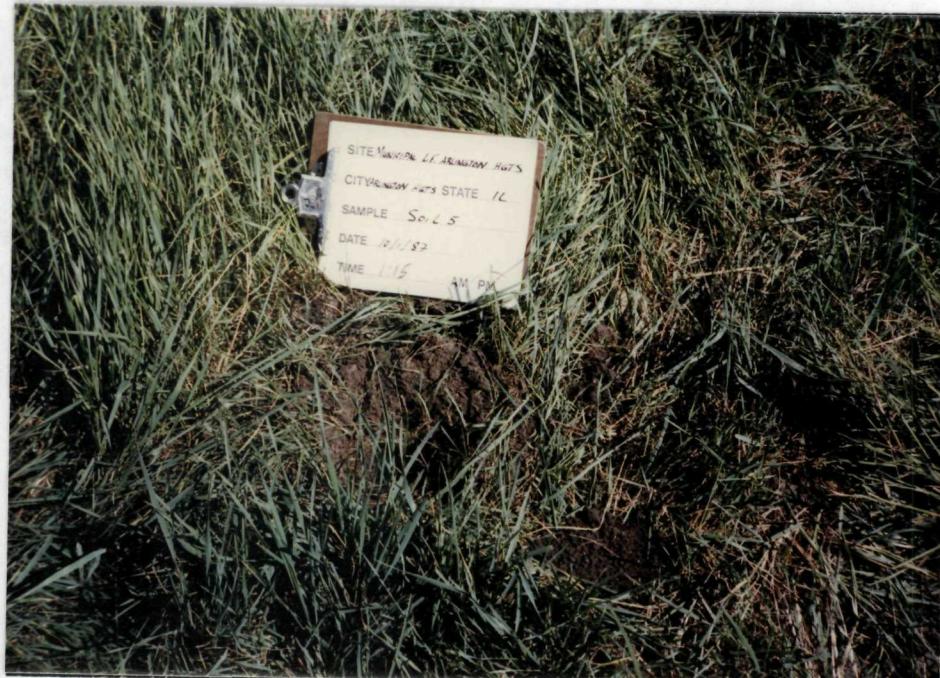
Soil 6 (S6)

DESCRIPTION: BACK GROUND SOIL SAMPLE (S6) OUTSIDE OF THE FENCE AT THE SOUTH END OF SITE NEAR THE GATE. PLACARD IS INCORRECT IN STATING 'SOIL 5'.

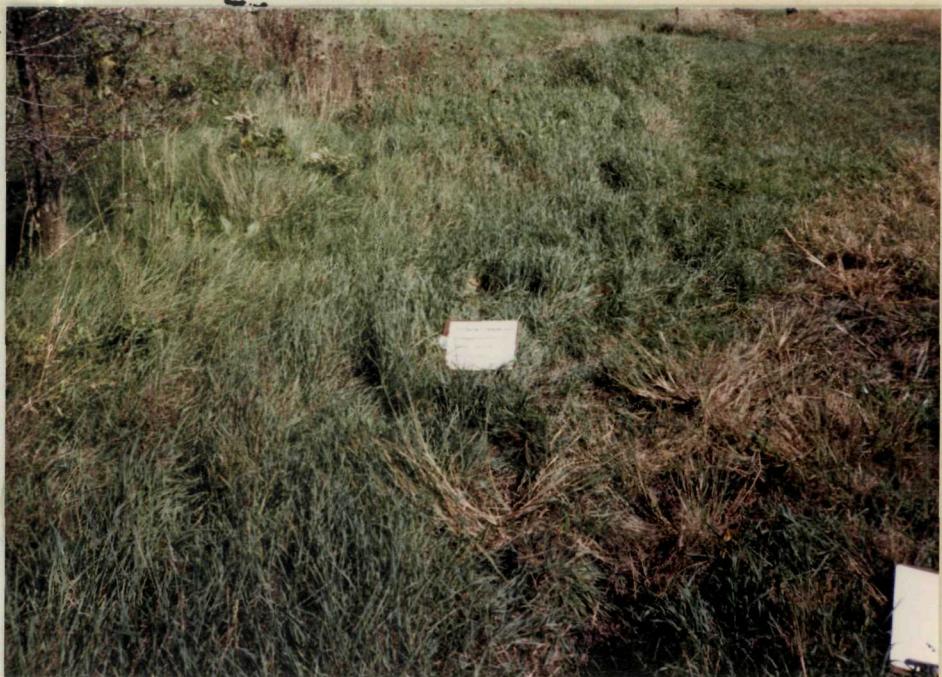
Soil 6 (S6)DESCRIPTION: FAR VIEW OF BACKGROUND SOIL SAMPLE.

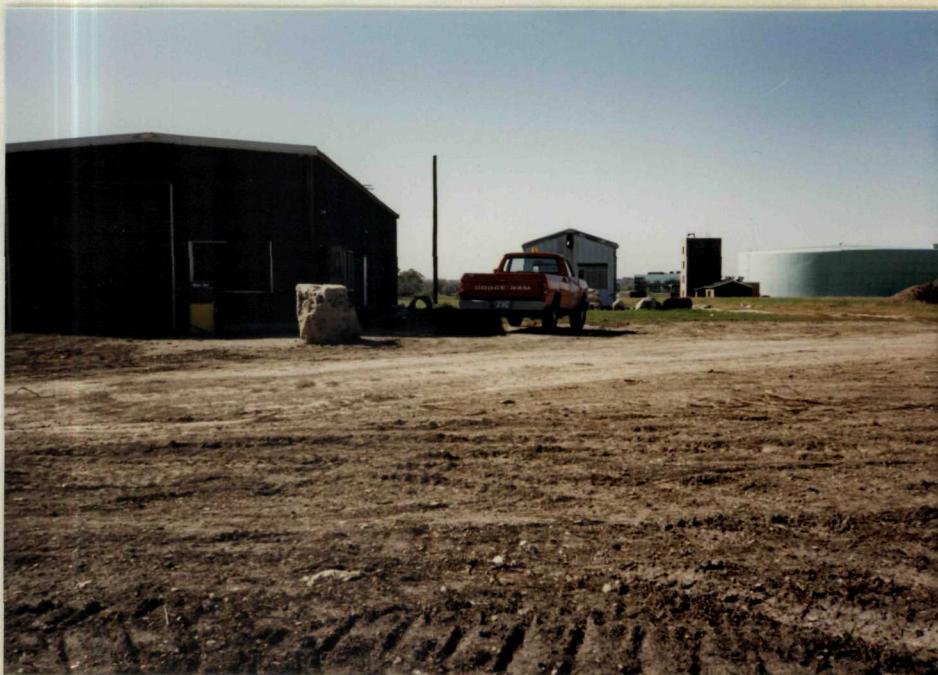
N/ADESCRIPTION: NEAR ENTRANCE GATE, MAINTENANCE HOUSE AND OTHER ON-SITE
STRUCTURES IN THE BACKGROUND; WELL IS IN THE MAINTENANCE BUILDING.

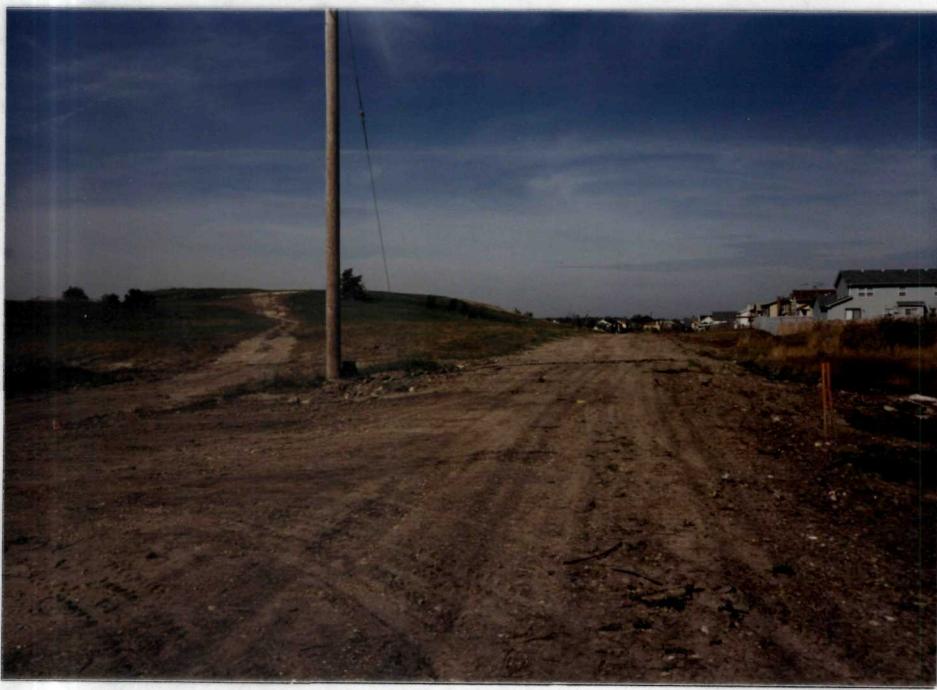
DESCRIPTION: INSIDE OF THE ENTRANCE GATE. NOTE THE LARGE HILL AND THE PROXIMITY OF HOUSES TO THE EAST OF THE HILL.
